Asbestos and Lead-Based Paint Report  
Former Kathleen Mitchell Elementary School  
College Park, Fulton County, Georgia

May 7, 2020

## Asbestos and Lead-Based Paint Report

Date: May 7, 2020

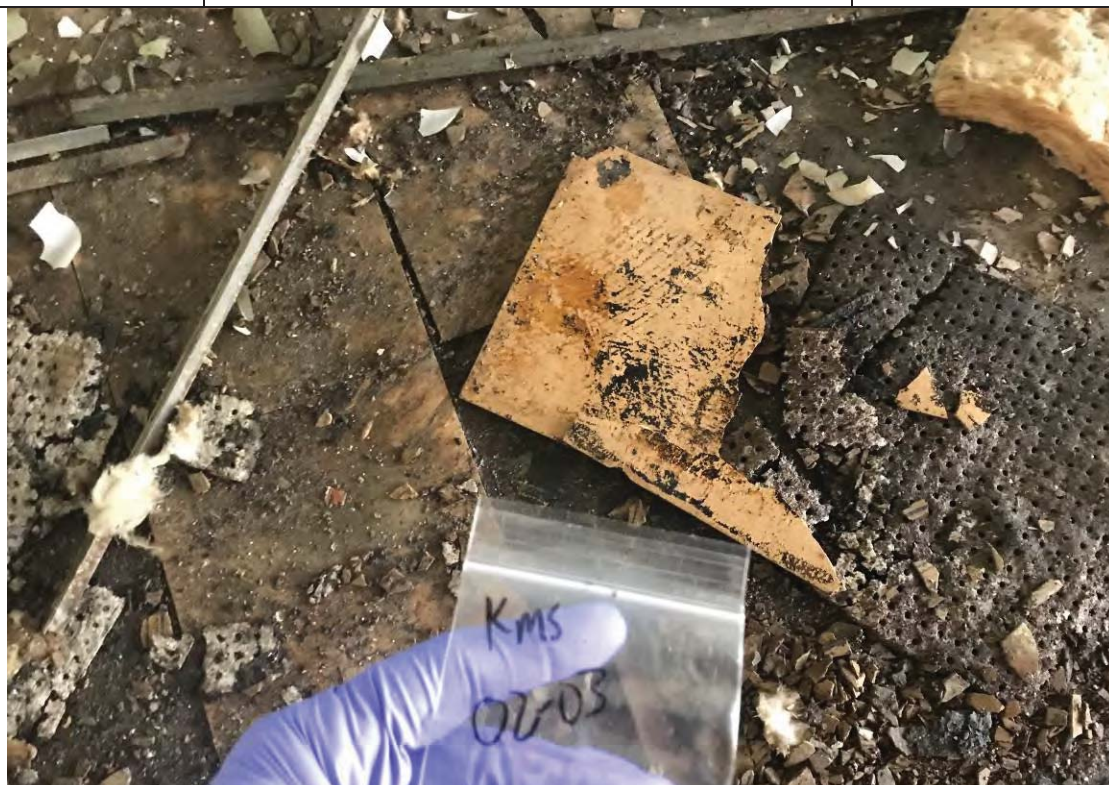
The gray 9"x9" VFT and associated black mastic was observed throughout the school building as well as the black mastic underlain by the white 12"x12" VFT. Please note that given the building material condition, Cardno was unable to differentiate between different floor tiles outside of its size, and therefore all 9"x9" VFT were treated as one HA and all 12"x12" were treated as one HA. For quantification purposes and given the building condition, all floor tile and associated mastic were measured as one uniform material, and total approximately 43,000 ft<sup>2</sup>. Overall the gray 9"x9" VFT and black mastic was in very poor condition, and as such is considered a friable material.

Confirmed ACM in Class  
Room 16; Gray 9"x9" VFT  
and associated black  
mastic.

- The identified asbestos containing material appeared to be in very poor condition with significant deterioration and damages. The overall condition of the building materials was such that non-ACM debris was inextinguishable from identified ACM debris. Therefore, all building materials, with the exception of the concrete slab, metal framing, and concrete masonry unit (CMU) walling, should be treated as ACM and be removed or abated by a qualified asbestos abatement contractor.

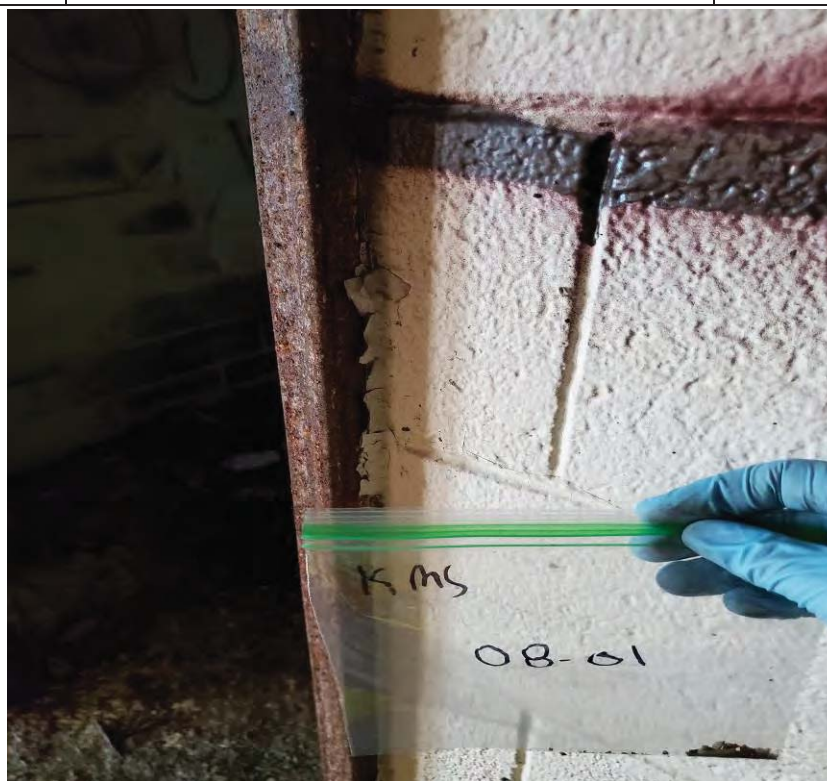
The interior white door caulk, totaling approximately 150 LF; interior beige window caulk, totaling approximately 180 LF; and interior gray caulk on fire extinguisher cabinets, totaled approximately 60 LF. Overall the various caulking identified was in poor condition and as such is considered a friable material

Confirmed ACM in Hall 2;  
Interior white door caulk.

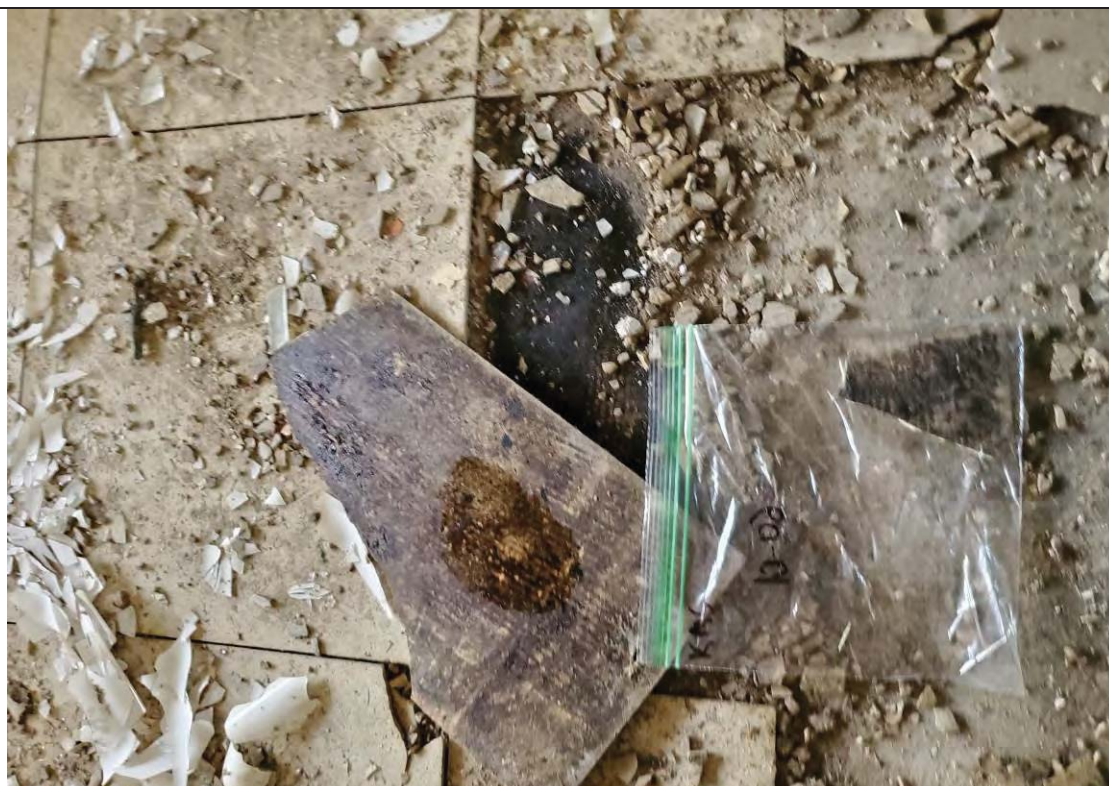
Photo No.  
**4**

Confirmed ACM in Class  
Room 7; Black mastic  
underlain by white 12"x12"  
VFT.

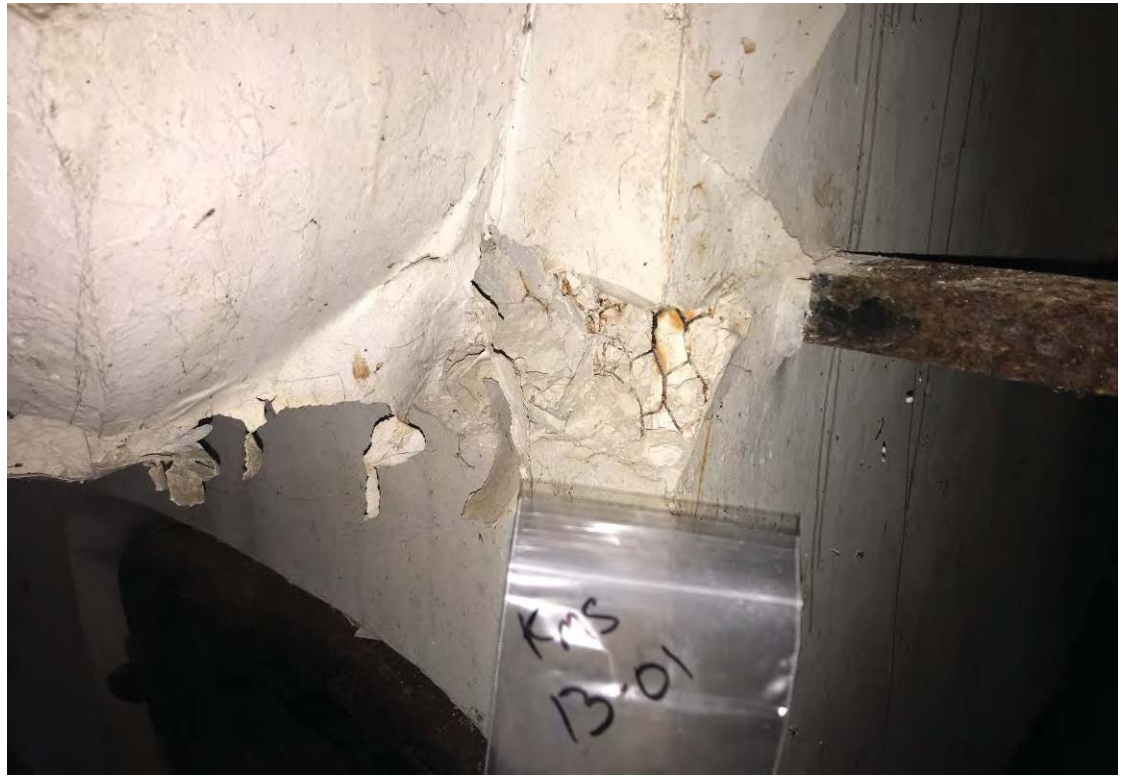
The boiler mastic identified totaled approximately 150 ft<sup>2</sup>, the 6-inch pipe elbows identified totaled approximately 60 LF and the 12-inch pipe elbows identified totaled approximately 60 LF. The white pipe wrap identified totaled approximately 100 LF and the transite piping identified totaled approximately 50 LF. These materials were in poor condition and are considered a TSI friable material. Cardno observed labels on the boiler indicating the boiler is “Asbestos Free”; however, analytical results indicate the boiler contains asbestos.

Confirmed ACM in Boiler  
Room; mastic on boiler.

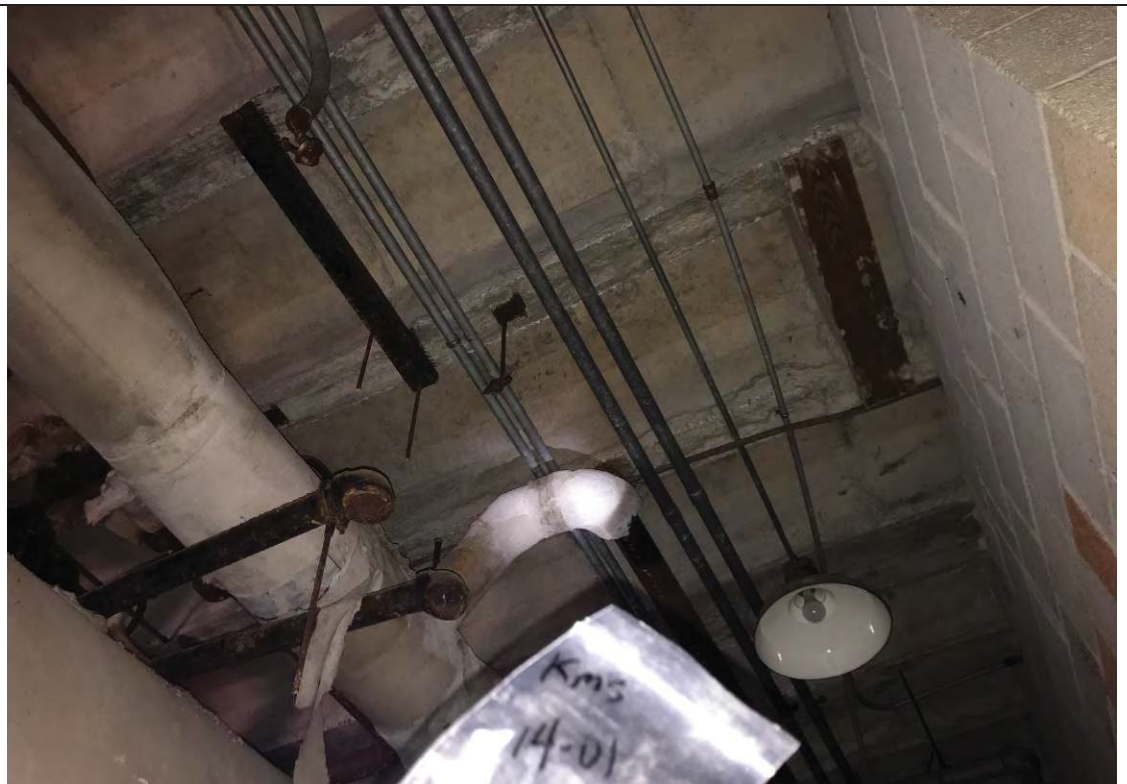
Photo No.

Confirmed ACM in Boiler  
Room; 6-inch pipe elbow.

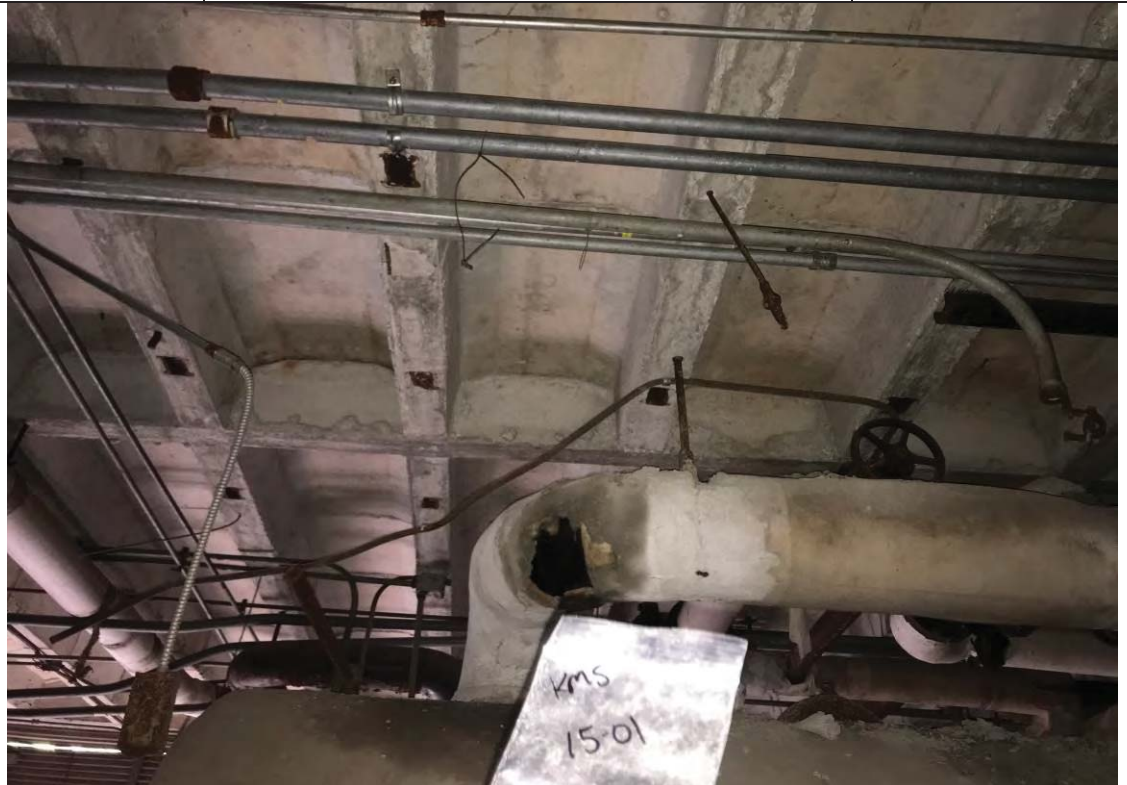
Confirmed ACM in Boiler  
Room; 12-inch pipe elbow.

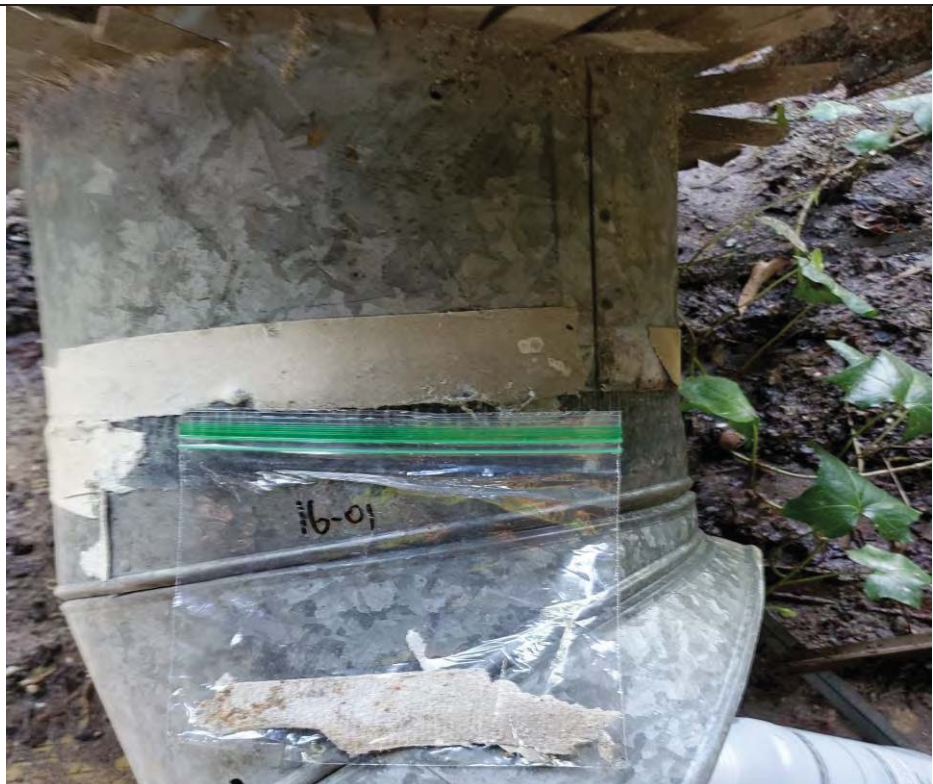
Photo No.

The white TSI wrap identified totaled approximately 100 linear feet and the HVAC TSI insulation wrap totaled approximate 75 ft<sup>2</sup>. These materials were in poor condition and are considered a TSI friable material.

Confirmed ACM in  
Cafeteria; White pipe  
wrap.

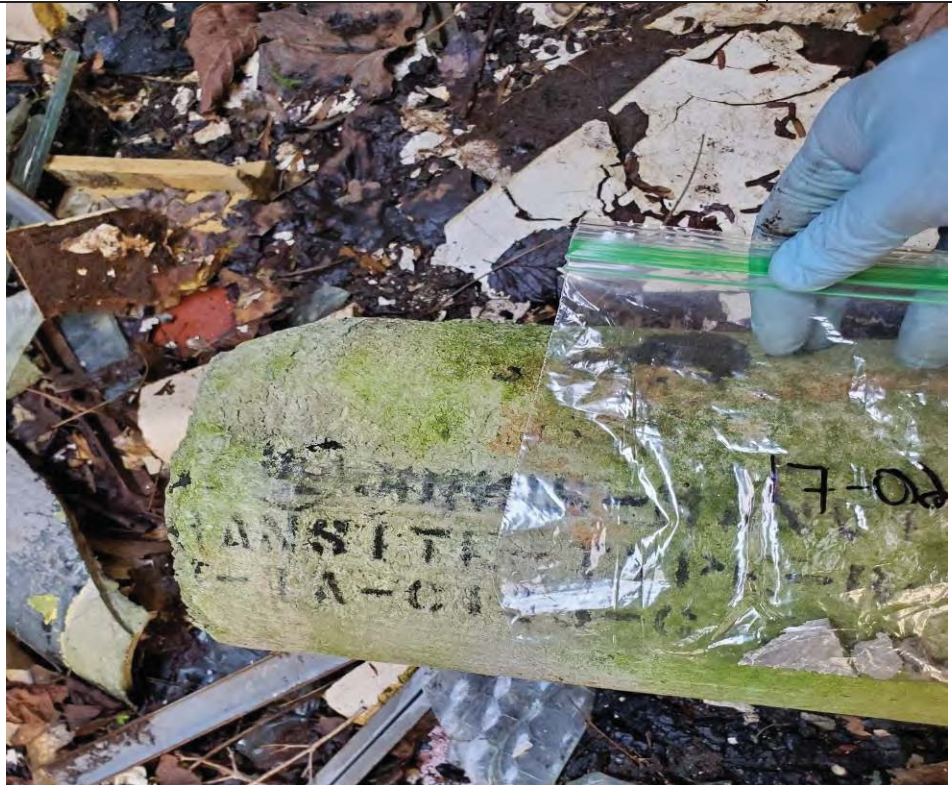
Confirmed ACM in Kitchen;  
Transite piping.

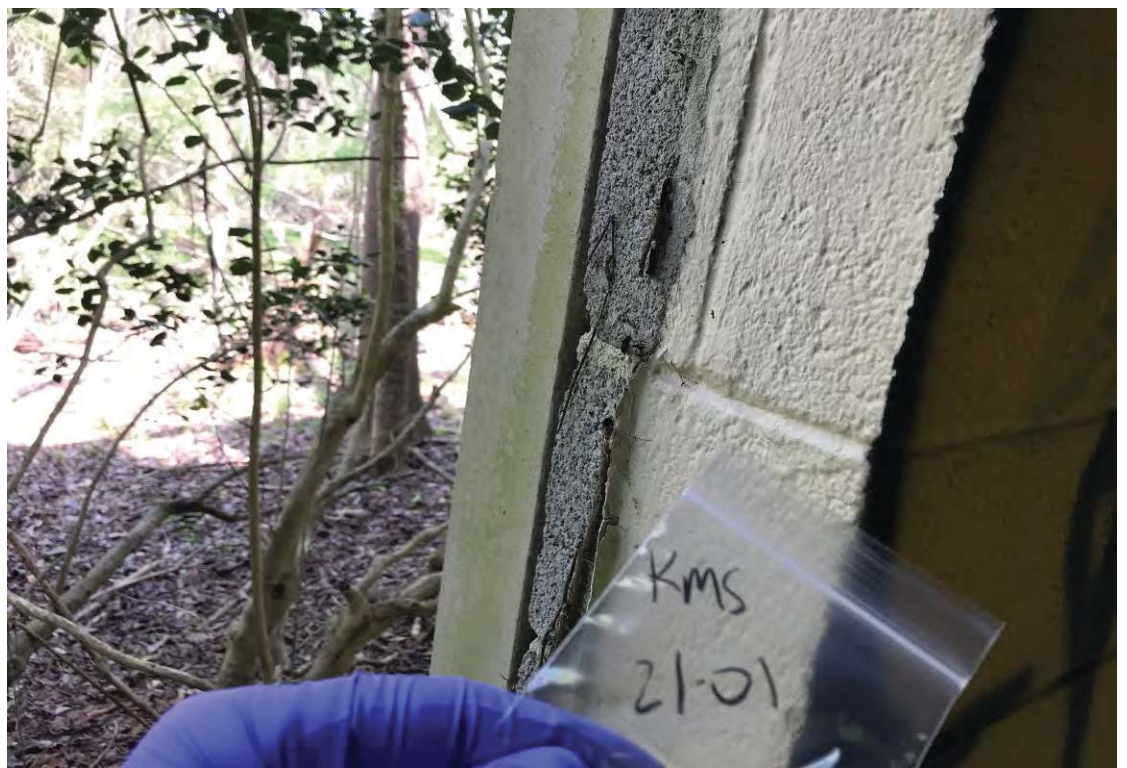
**Photo No.**  
**10**

Confirmed ACM in  
Cafeteria; Interior  
window caulk.

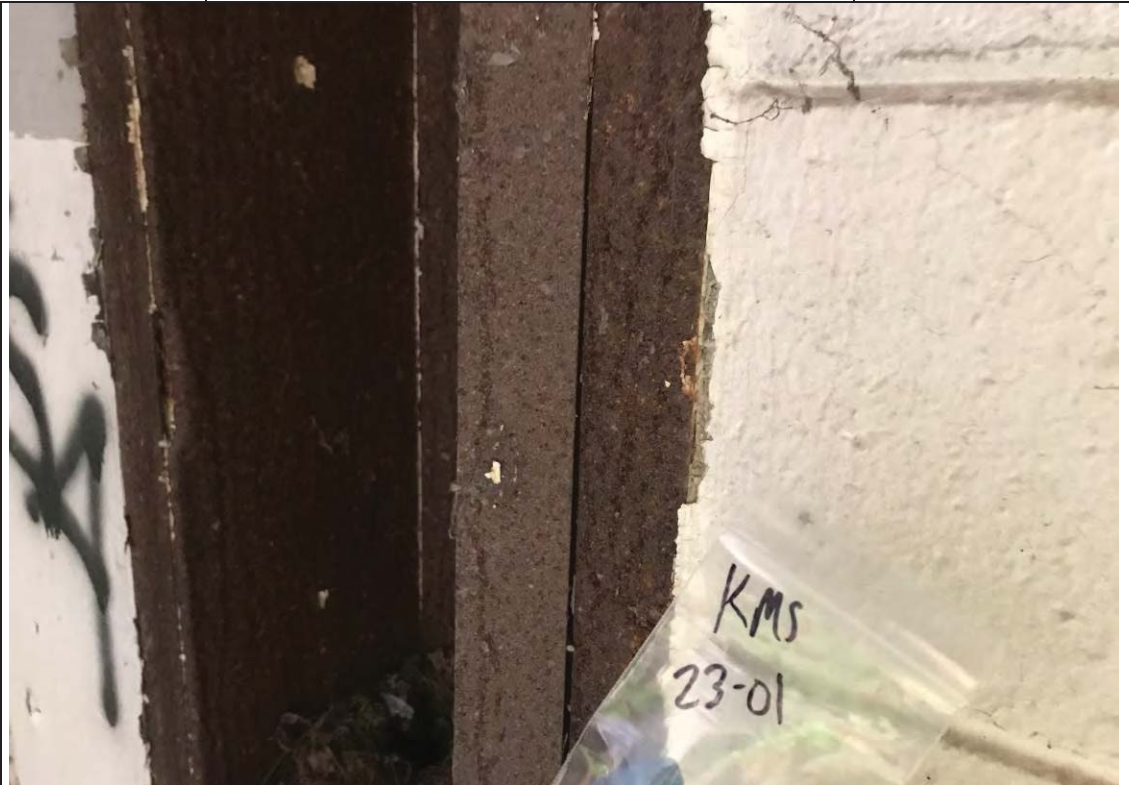
Confirmed ACM in Hall 2;  
Gray caulk on fire  
extinguisher cabinets.

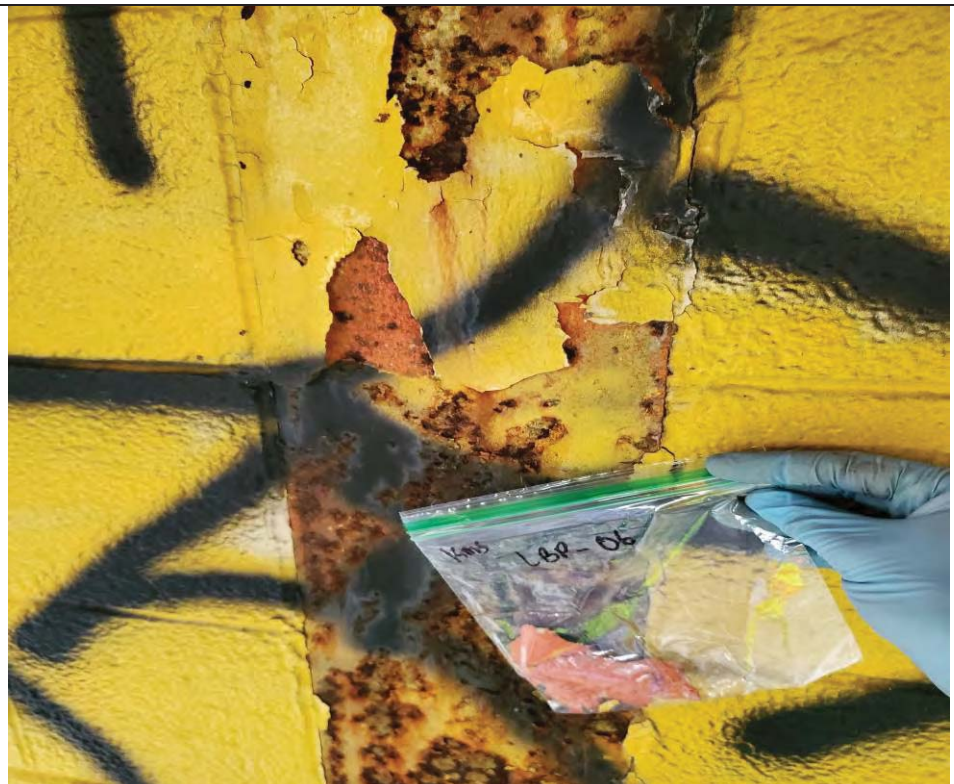
**Photo No.**  
**12**

Overall the identified lead-based paint was in poor condition, with cracking and peeling paint.

Confirmed LBP in  
Cafeteria; Yellow paint  
on CMU.

- The identified lead-based paint appeared to be in very poor condition. There are OSHA regulations and requirements which should be taken into consideration during renovation and demolition activities that may disturb any concentration of lead containing building materials or paint. As the property is anticipated to be demolished, due to the presence of lead on various painted surfaces, toxicity characteristic leachate procedure (TCLP) analysis for lead should be conducted on any construction debris to determine if the material should be characterized as a hazardous waste prior to disposal.

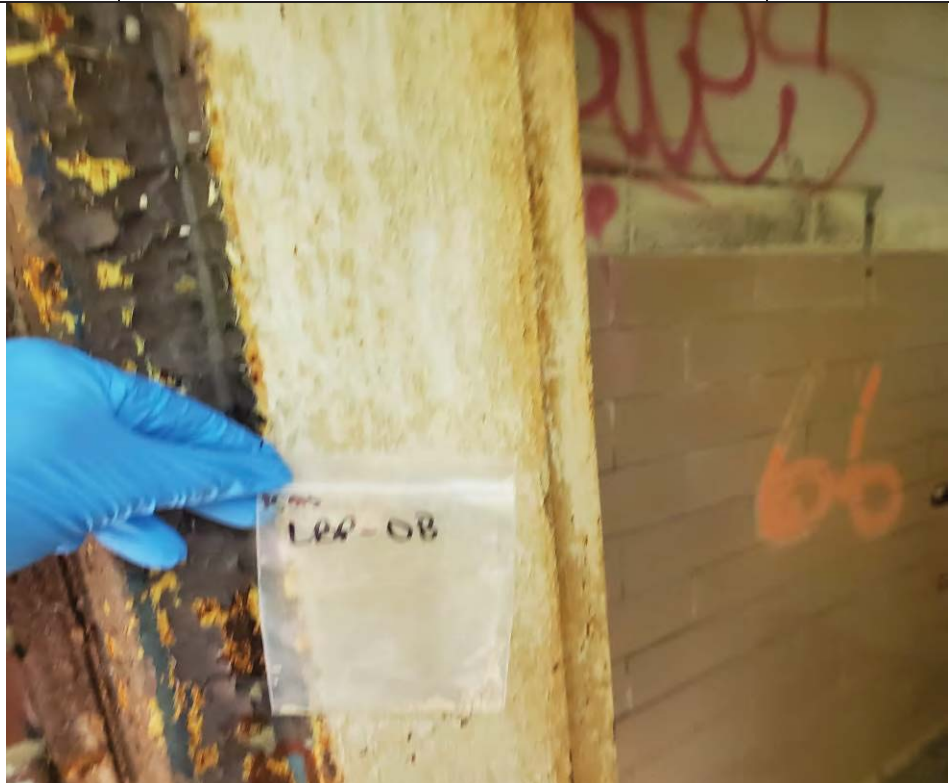
Confirmed LBP on door  
frame in Bathroom 8; White  
paint on metal door frame.

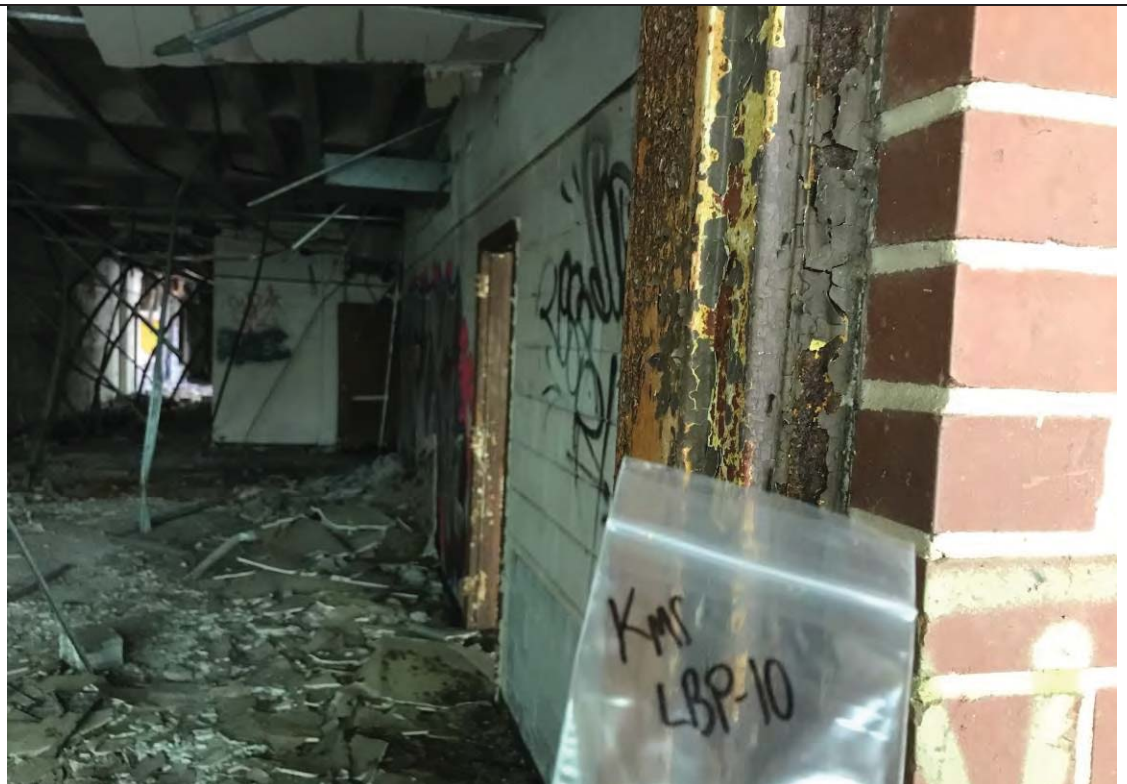
Photo No.  
**14**

Confirmed LBP on door  
frame in Hall 2; Brown  
paint on metal door  
frame.
